O Ring Failure Analysis

How to Assess a Seal Failure:

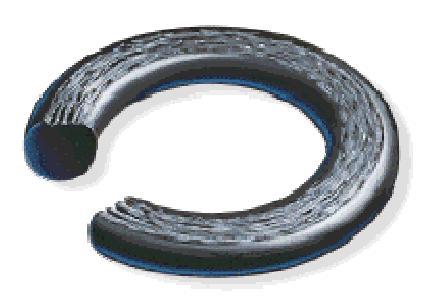
Abrasion

Description: The seal or parts of the seal exhibit a flat surface parallel to the direction or motion. Loose particles and scrapes may be found on the seal surface.

Key Factors: Rough sealing surfaces. Excessive temperature. Process environment containing abrasive particles. Dynamic motion. Poor elastomer surface finish.

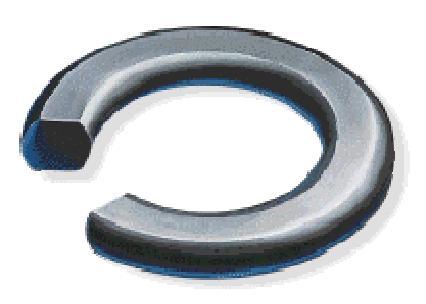
Compression Set

Description: The seal exhibits a flat-sided crosssection, the flat sides corresponding to the mating seal surfaces.

Key Factors: Excessive compression. Excessive temperature. Incompletely cured elastomer. Elastomer with high compression set. Excessive volumes swell in chemical.

Corrective Action: Low compression set elastomer. Proper gland design for the specific elastomer. Confirm material compatibility.

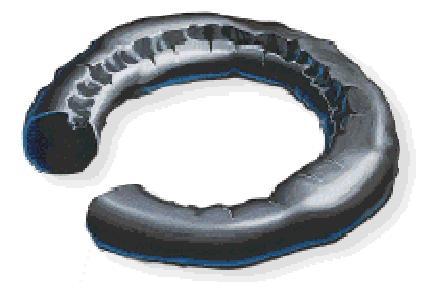
Chemical Degradation

Description: The seal may exhibit many signs of degradation including blisters, cracks, voids or discoloration. In some cases, the degradation is observable only by measurement of physical properties.

Key Factors: Incompatibility with the chemical and/or thermal environment.

Corrective Action: Selection of more chemically resistant elastomer.

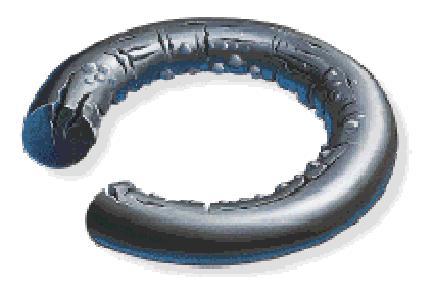
Explosive Decompression

Description: The seal exhibits blisters, pits or pocks on its surface. Absorption of gas at high pressure and the subsequent rapid decrease in pressure. The absorbed gas blisters and ruptures the elastomer surface as the pressure is rapidly removed.

Key Factors: Rapid pressure changes. Low-modulus/ hardness elastomer.

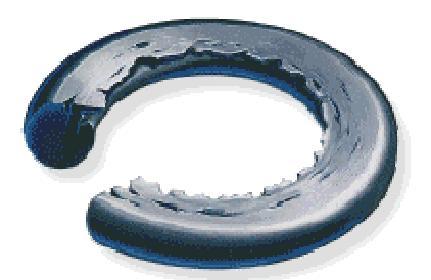
Extrusion

Description: The seal develops ragged edges (generally on the low-pressure side) which appear tattered.

Key Factors: Excessive clearances. Excessive pressure. Low-modulus/ hardness elastomer. Excessive gland fills. Irregular clearance gaps. Sharp gland edges. Improper sizing.

Corrective Action: Decrease clearances. Highermodulus/ hardness elastomer. Proper gland design. Use of polymer backup rings.

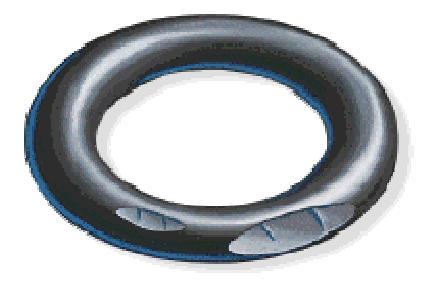
Installation Damage

Description: The seal or parts of the seal may exhibit small cuts, nicks or gashes.

Key Factors: Sharp edges on glands or components. Improper sizing of elastomer. Low-modulus/ hardness elastomer. Elastomer surface contamination.

Corrective Action: Remove all sharp edges. Proper gland design. Proper elastomer sizing. Higher-modulus/ hardness elastomer.

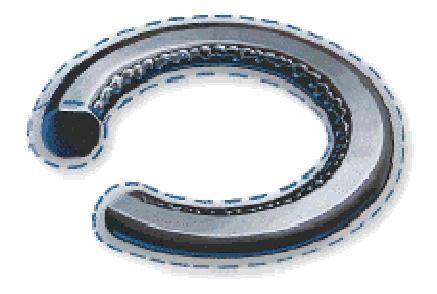
Outgassing / Extraction

Description: This failure is often very difficult to detect from examination of the seal. The seal may exhibit a decrease in cross-sectional size.

Key Factors: Improper or improperly cured elastomer. High vacuum levels. Low hardness/ plasticised elastomer.

Corrective Action: Avoid plasticised elastomers. Ensure all seals are properly post-cured to minimise outgassing.

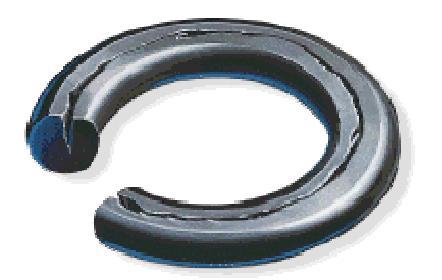
Overcompression

Description: The seal exhibits parallel flat surfaces (corresponding to the contact areas) and may develop circumferential splits within the flattened surfaces.

Key Factors: Improper design—failure to account for thermal or chemical volume changes, or excessive compression.

Corrective Action: Gland design should take into account material responses to chemical and thermal environments.

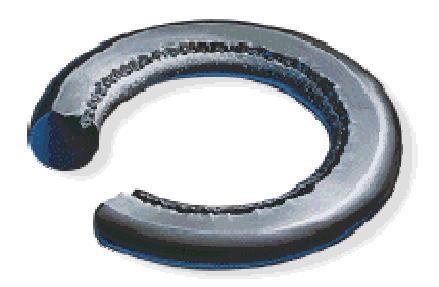
Plasma Degradation

Description: The seal often exhibits discolouration, as well as powdered residue on the surface and possible erosion of elastomer in the exposed areas.

Key Factors: Chemical reactivity of the plasma. Ion bombardment (sputtering). Electron bombardment (heating). Improper gland design. Incompatible seal material.

Corrective Action: Plasma-compatible elastomer and compound. Minimise exposed area. Examine gland design.

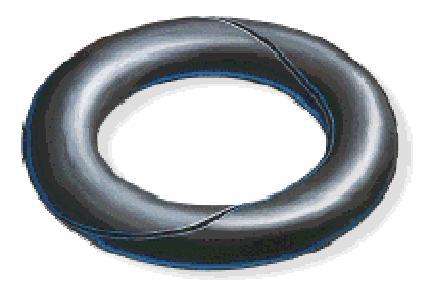
Spiral Failure

Description: The seal exhibits cuts or marks which spiral around its circumference.

Key Factors: Difficult or tight installation (static). Slow reciprocating speed. Low-modulus/ hardness elastomer. Irregular O-ring surface finish (including excessive parting line). Excessive gland width. Irregular or rough gland surface finish. Inadequate lubrication.

Corrective Action: Correct installation procedures. Higher-modulus elastomer. Internally-lobed elastomers. Proper gland design. Gland surface finish of 8–16 micro inches RMS. Possible use of polymer backup rings.

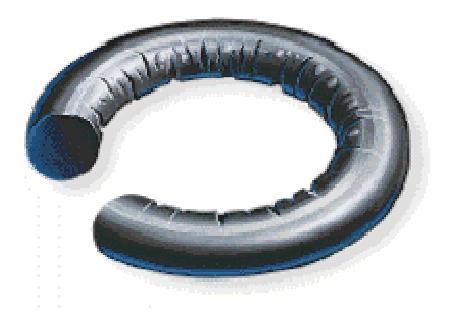
Thermal Degradation

Description: The seal may exhibit radial cracks located on the highest temperature surfaces. In addition, certain elastomers may exhibit signs of softening (a shiny surface as a result of excessive temperatures).

Key Factors: Elastomer thermal properties. Excessive temperature excursions or cycling.

Corrective Action: Selection of an elastomer with improved thermal stability. Evaluation of the possibility of cooling sealing surfaces.
